# Manhole Inspection Summary

Manhole # S25MM\_016MH

**Location** Address: **2332 MORRIS ST**

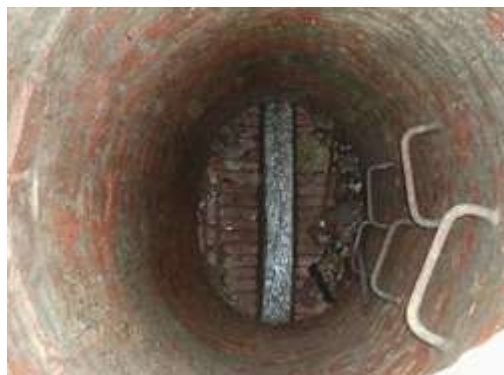
Top View

Corroded and missing steps. Bench debris.

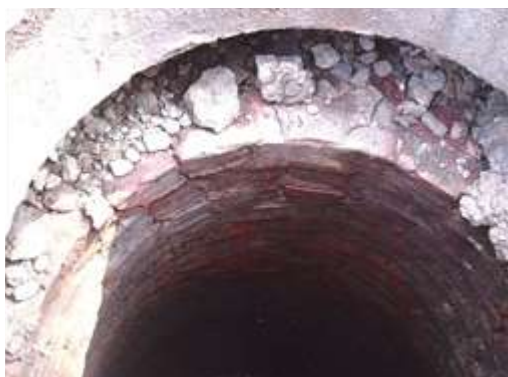
Defect

Frame leaks. Frame offset. Adjustment deterioration, loose brick and infiltration. Corbel infiltration - other side.

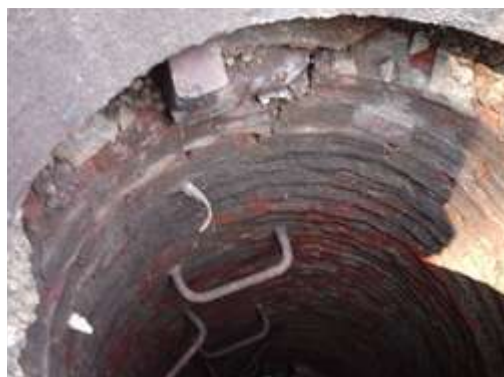
Defect

Frame leaks. Adjustment deterioration, loose brick and infiltration. Corbel infiltration.

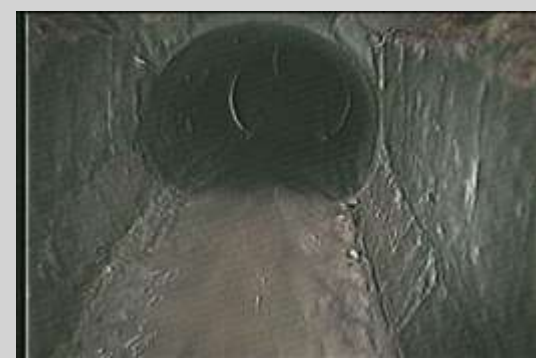
### 8 in. Circular Gravity Sewer Pipe Out @ 12 O'Clock

Infiltration: **Evidence** Pipe Seal Cond: **Cracked**

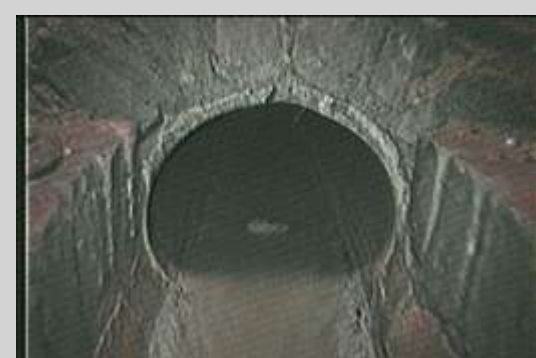
### 8 in. Circular Gravity Sewer Pipe In @ 6 O'Clock

Channel deterioration.
